**Wheel-squeal mitigation measures implemented on the
Mission Valley West extension of the Light Rail Transit
system of San Diego, CA, USA**

**Reprinted from Rail Engineering International
Edition 1999 Volume 28 Number 4**

Charles Coval
Track Supervisor
San Diego Trolley, Inc.
San Diego, USA

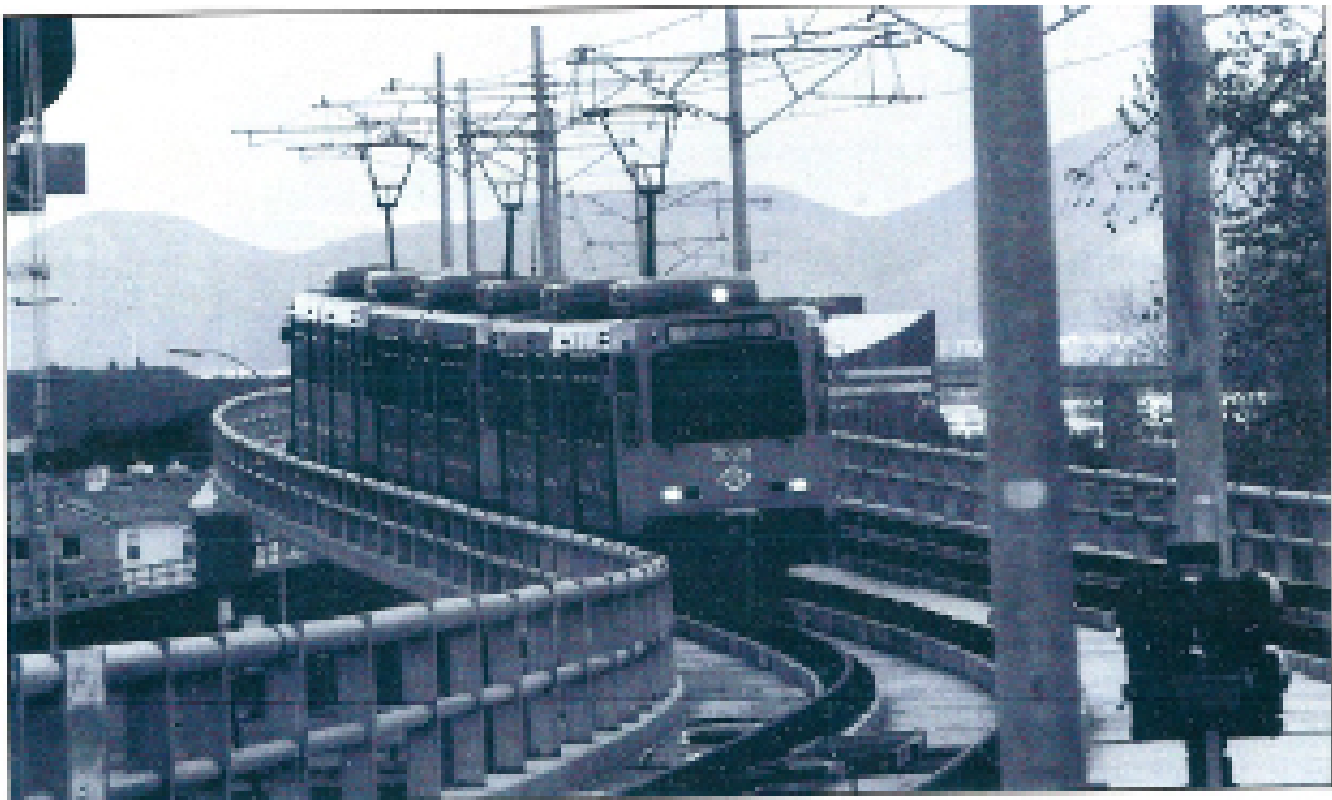
First, a study was carried out to locate the noise areas on the line. It was found that wheel squeal was produced on curves featuring a radius of less than 1200 feet (365 m) and a grade of 3% or more, as on a rigid track (concrete sleepers and direct fixation) (Figs. 2 and 3).

Fig. 2: Light rail vehicle traveling on a deflating curved section of the Mission Valley West extension

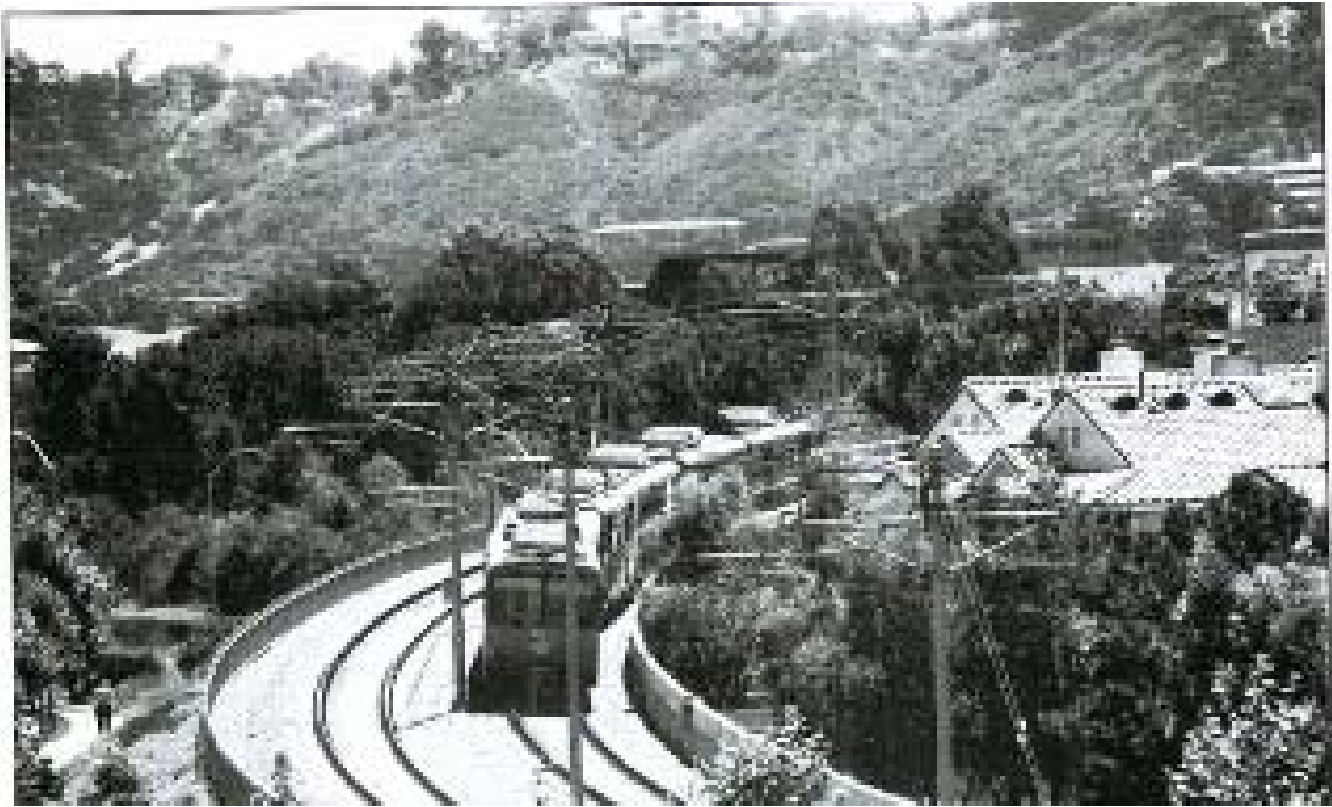
Noise could be eliminated for a 24-hour period by hand-applying grease, or using a spray-on graphite lubricant, but this only solved the problem short term as the grease migrated to the top of the rail where it caused wheels to slip thus activating the sanders of the LRVs

Subsequently, the sand would mix with the grease and accelerate the wiping of the grease off the rails. When this was discovered, it was decided to install wayside lubricators

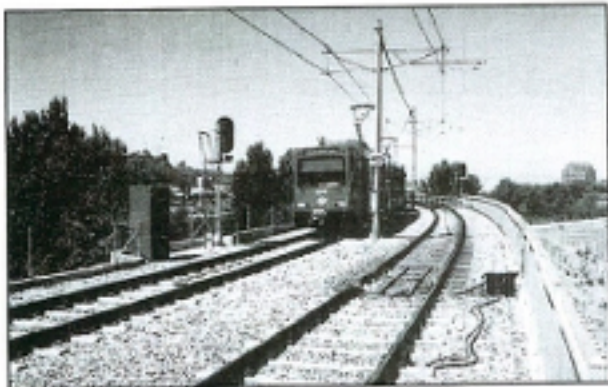
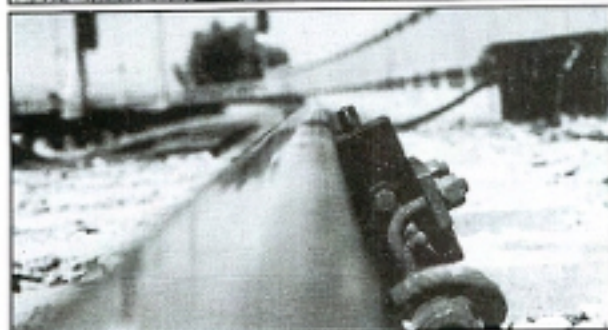
Fig. 4: Wayside lubricator installation (top), and close-up of attachment to the rail (bottom)

Generally, the called received concerned failure in the lubricator system itself, not a failure of the lubricant applied. A typical lubricator problem has, for instance, resulted from the development of an air gap in the system causing the pumps to cavitate. In other cases, a spring in the activator may have fallen off. All these problems can be very easily remedied.

Once the lubricators and Teflon-based grease were installed, however, it was found that the problems were not over yet. Fine-tuning by track maintenance personnel was still required. For instance, it was necessary to move some lubricating bars from zero cross level to 1/4-inch superelevation in the track to eliminate the noise. In another area, the wiping car was raised

closer to the wheel flange. This allowed the wheels to better spread the grease through the system.

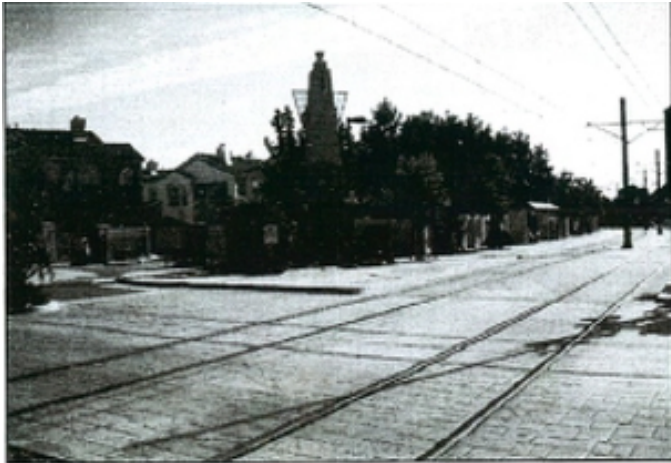
Fig. 5: Residential properties located very close to the Mission Valley West extension
